Subject: RE: Hatco Quarterly Progress Report 61

Re: Quality Assurance Project Plan Addendum

Crown Relocations Hot Spot Excavation Plan

Hatco Remediation Project / Woodbridge Pond Remediation Area

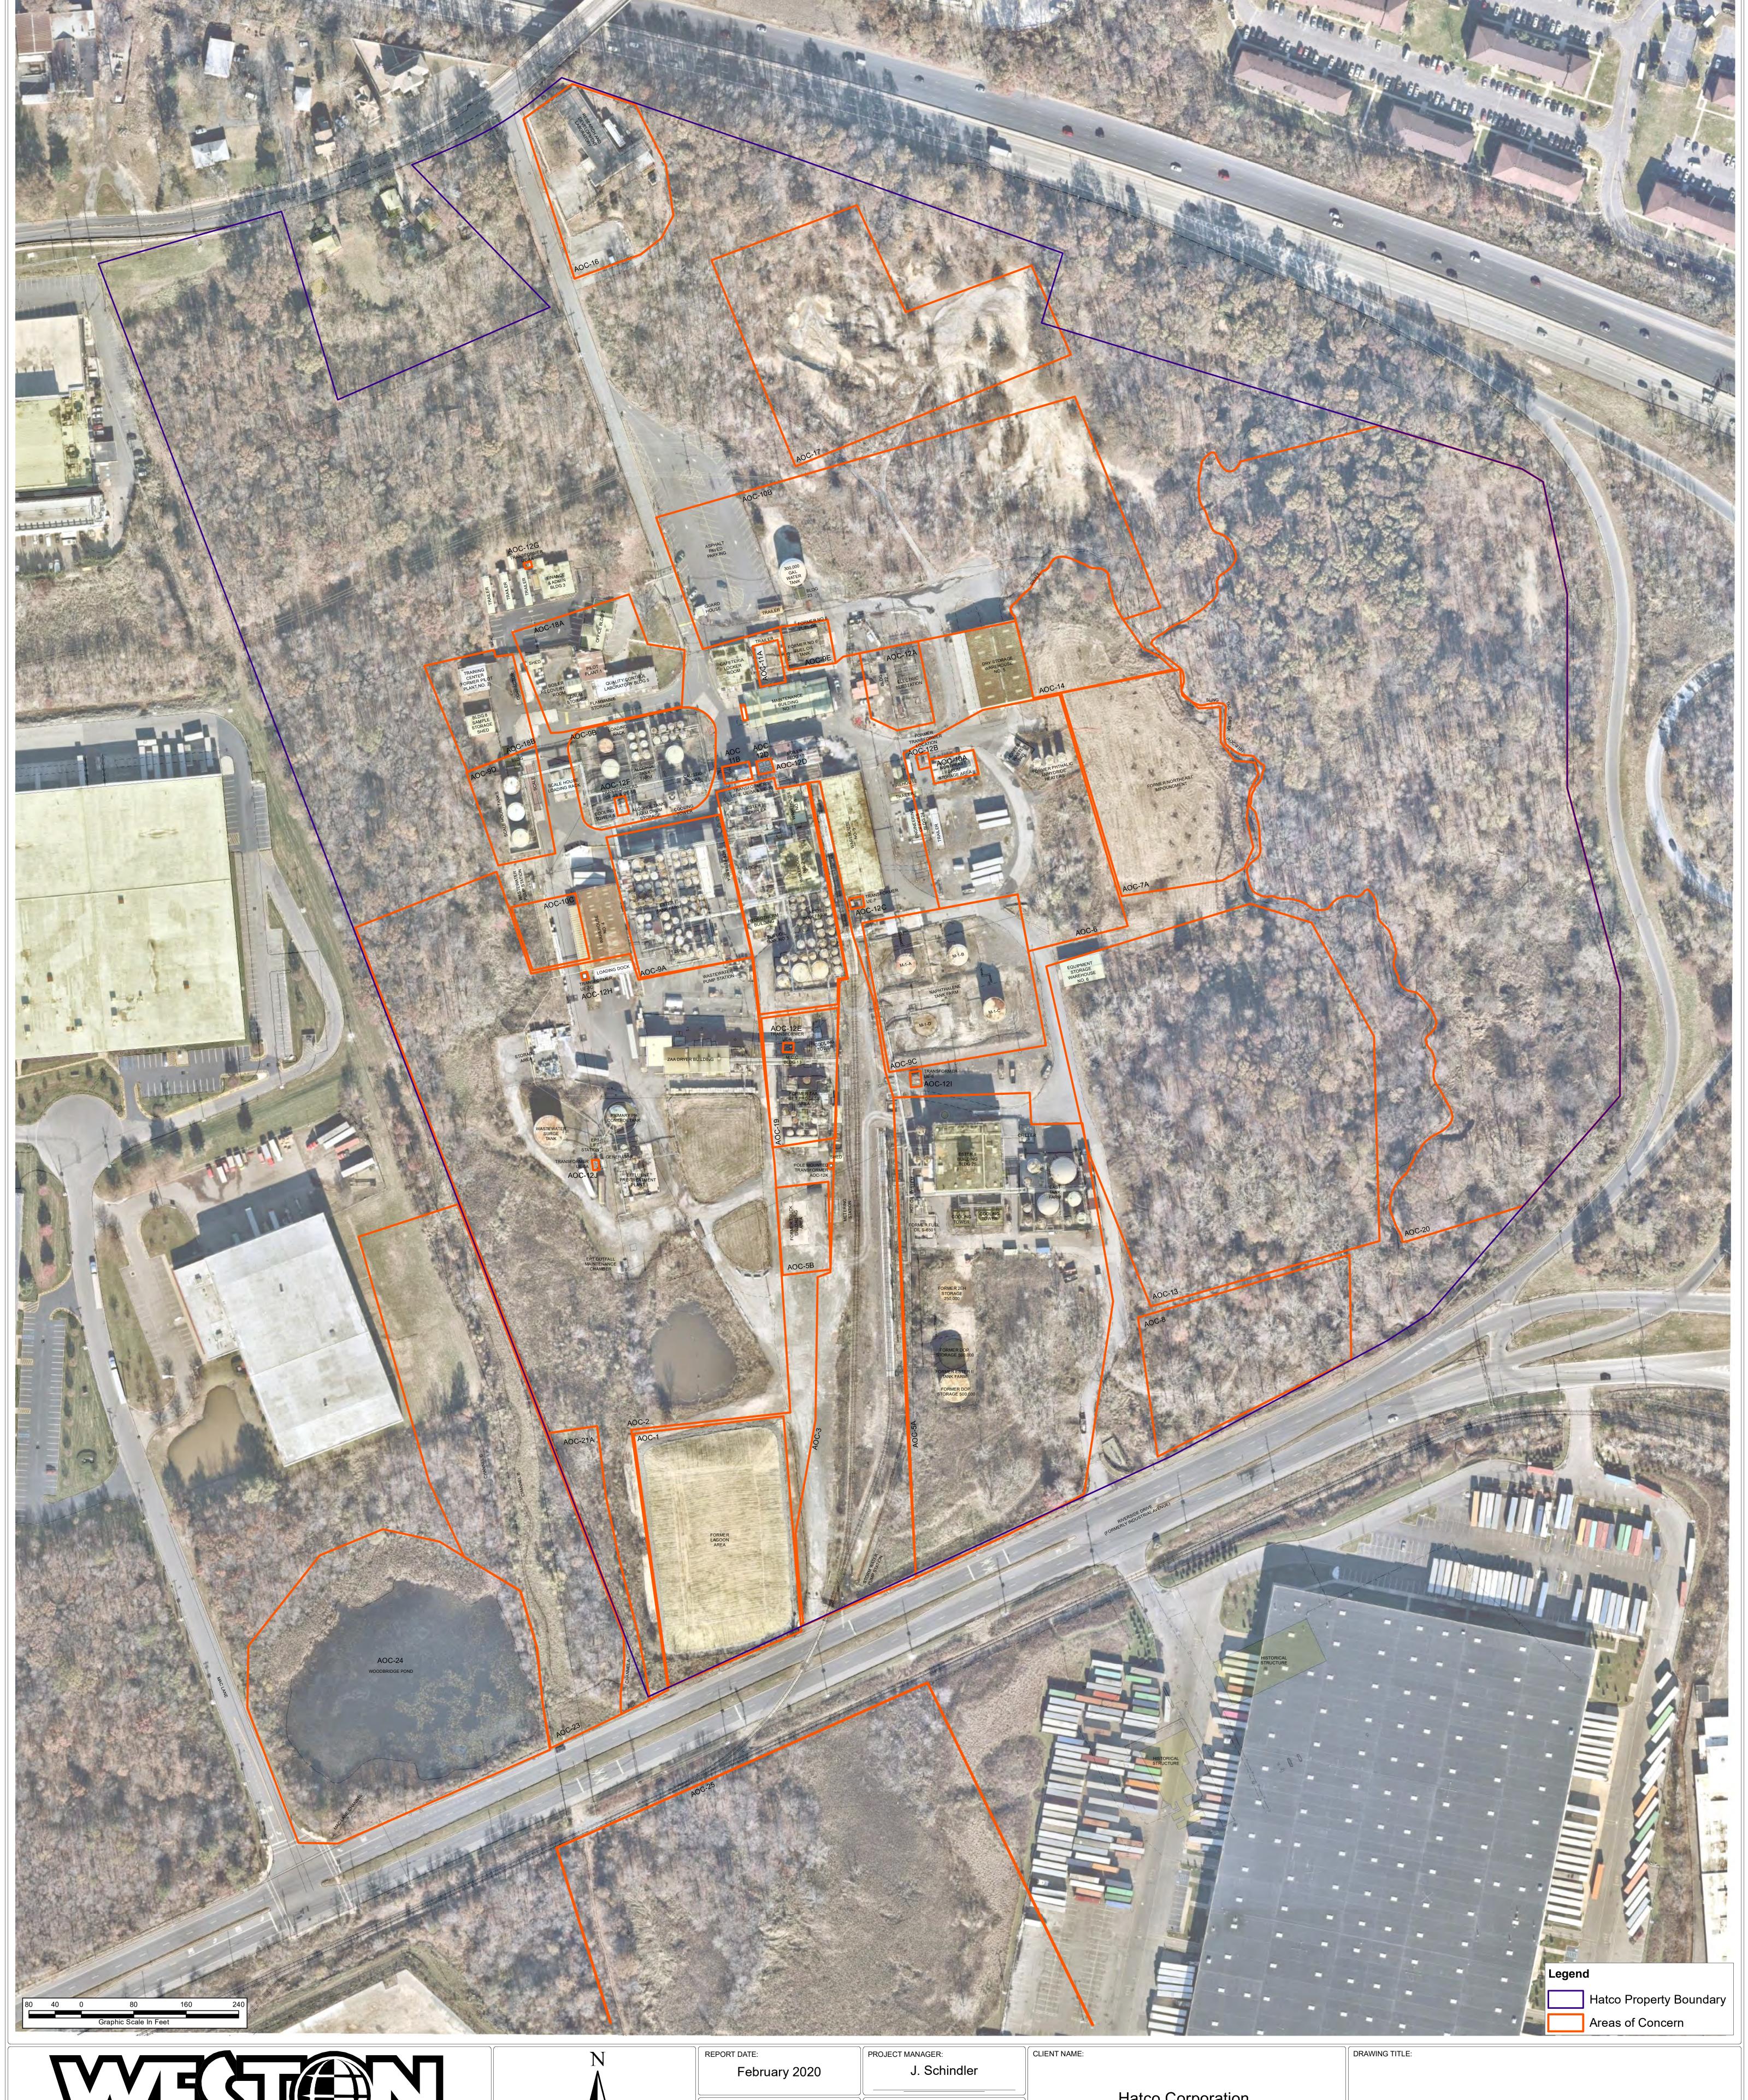
FIGURE 2:

Hatco Areas of Concern

This memorandum and attachments serve as an addendum to the Quality Assurance Project Plan (QAPP) for the Hatco remediation project, most recently revised May 22, 2017. This addendum is intended to support the excavation of an area of off-site contamination at Hatco Area of Concern (AOC) 23 designated as "Crown Relocations Hot Spot". The property, owned by Crown Relocations (Crown), is located at 200 Mac Lane, Woodbridge, New Jersey on Block 71, Lot 6 of Woodbridge Township Tax Maps. The property is located adjacent to the Hatco Site and Woodbridge Pond. **Figure 1** shows the Site Location. **Figure 2** shows the AOCs associated with the Hatco remediation project.

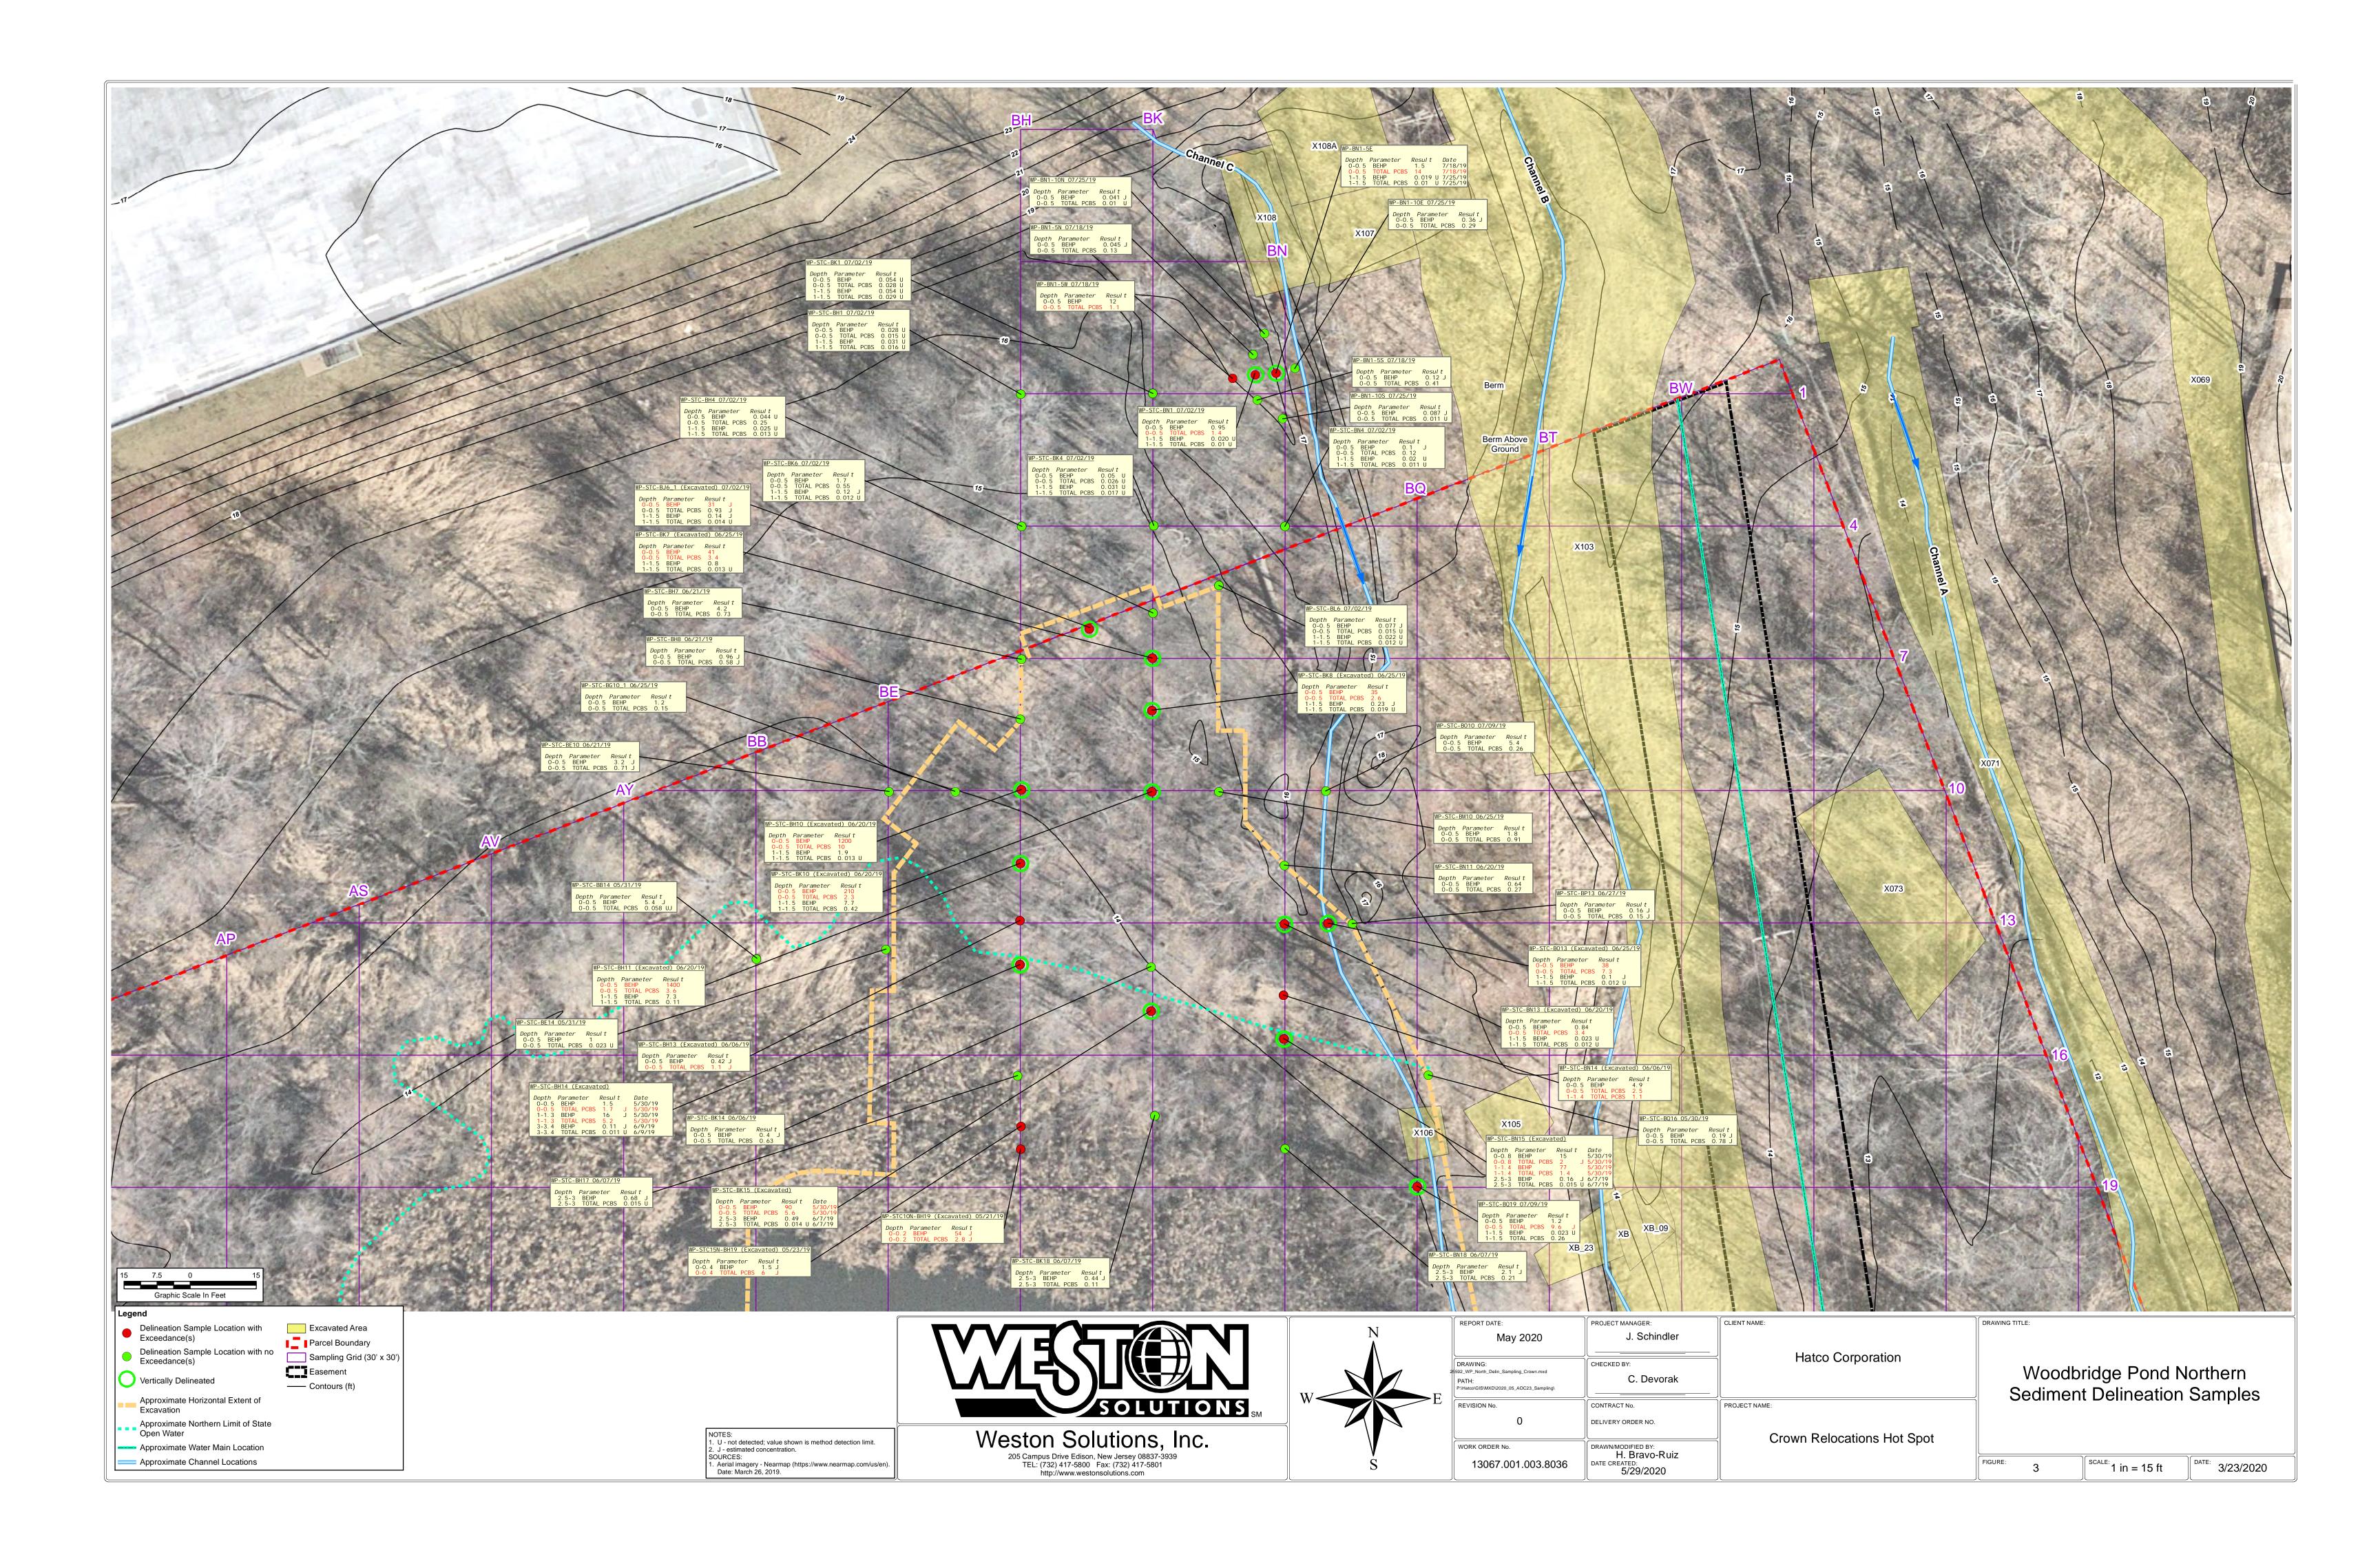
FIGURE 3:

Woodbridge Pond Northern Sediment Delineation Samples

The Alternate Remediation Standards are specified in the approved RAWPA 4, which are 22 mg/kg (milligrams per kilogram) (dry weight basis) for bis(2-ethylhexyl)phthalate (BEHP), and 1 mg/kg (dry weight basis) for PCBs in sediment. The sediment samples collected in July 2019 to delineate the extent of contamination on the Crown lot exhibited total PCB concentrations above the remediation criterion of 1 mg/kg. There were no BEHP exceedances. Based on the resulting data one discrete area requires excavation, approximately 230 square feet by one foot deep. **Figure 3** presents the Delineation Sample Results.

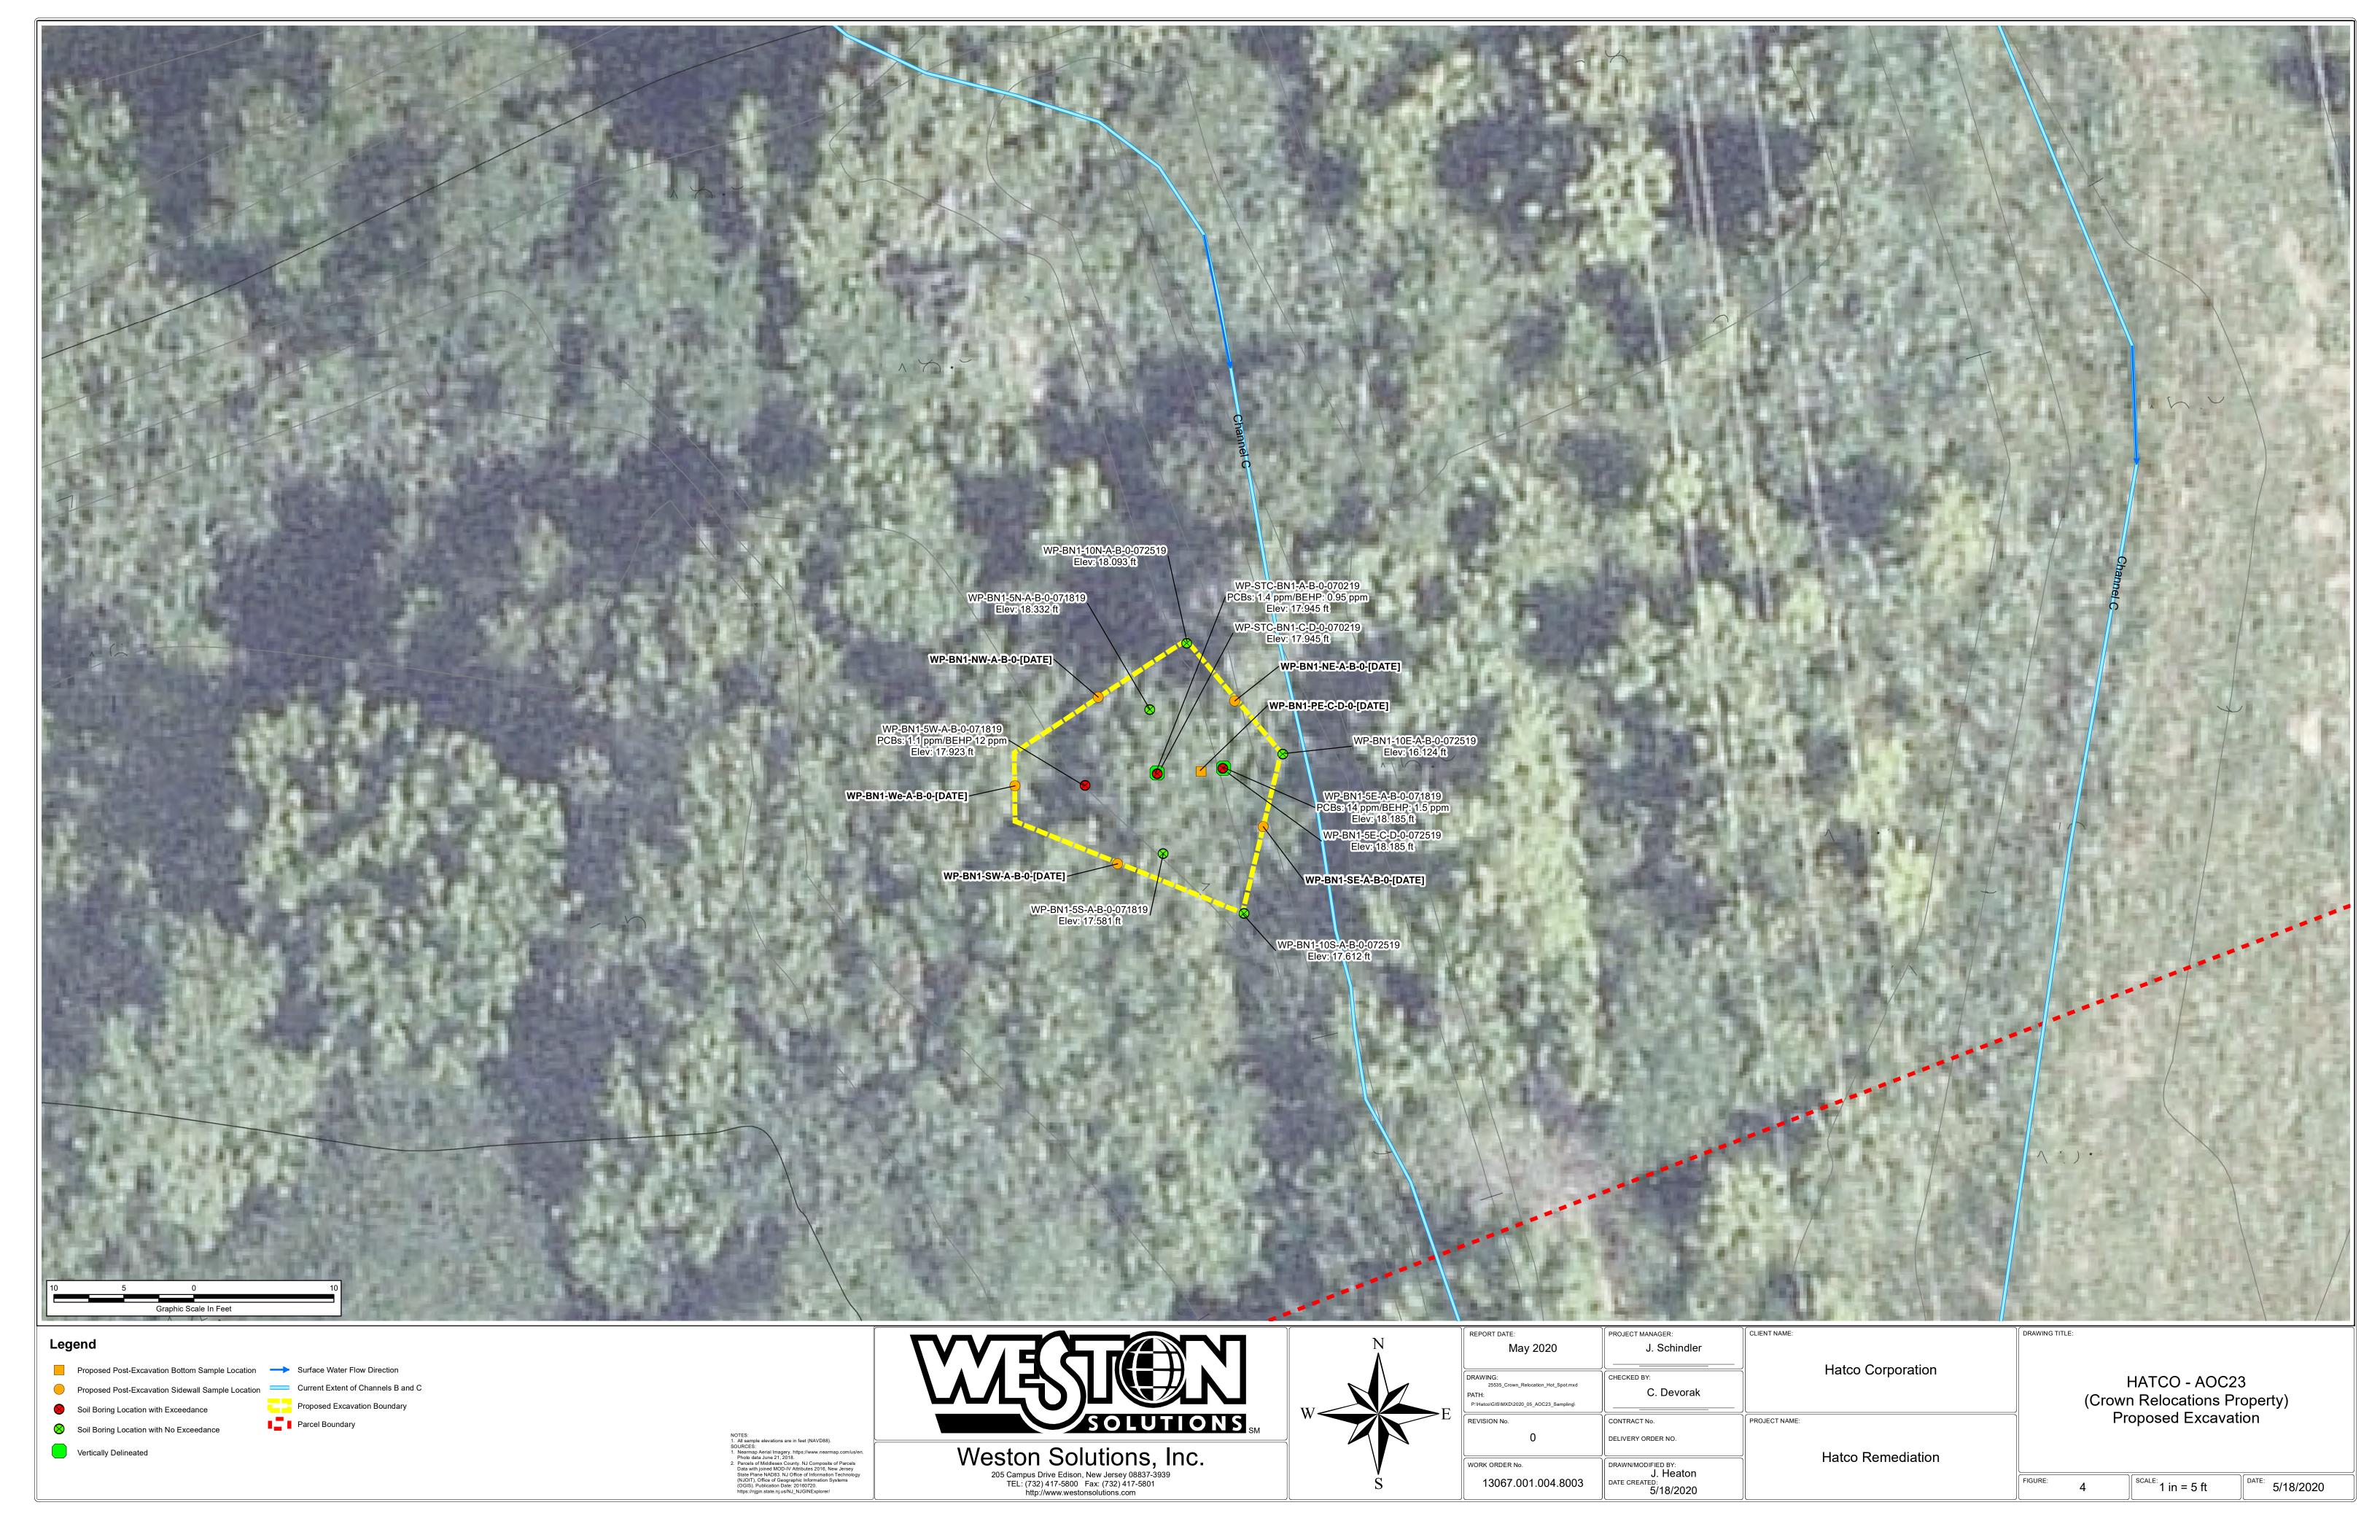
FIGURE 4:

Crown Relocations Hot Spot Proposed Excavation

The sample locations and the horizontal and vertical extent of the area of contamination to be removed are depicted on **Figure 4**. The impacted sediment is located in an area mapped as wetlands. Small trees and vegetation will be removed in order to access the planned excavation area. Sediment will be excavated using mechanical equipment, and the excavation will be

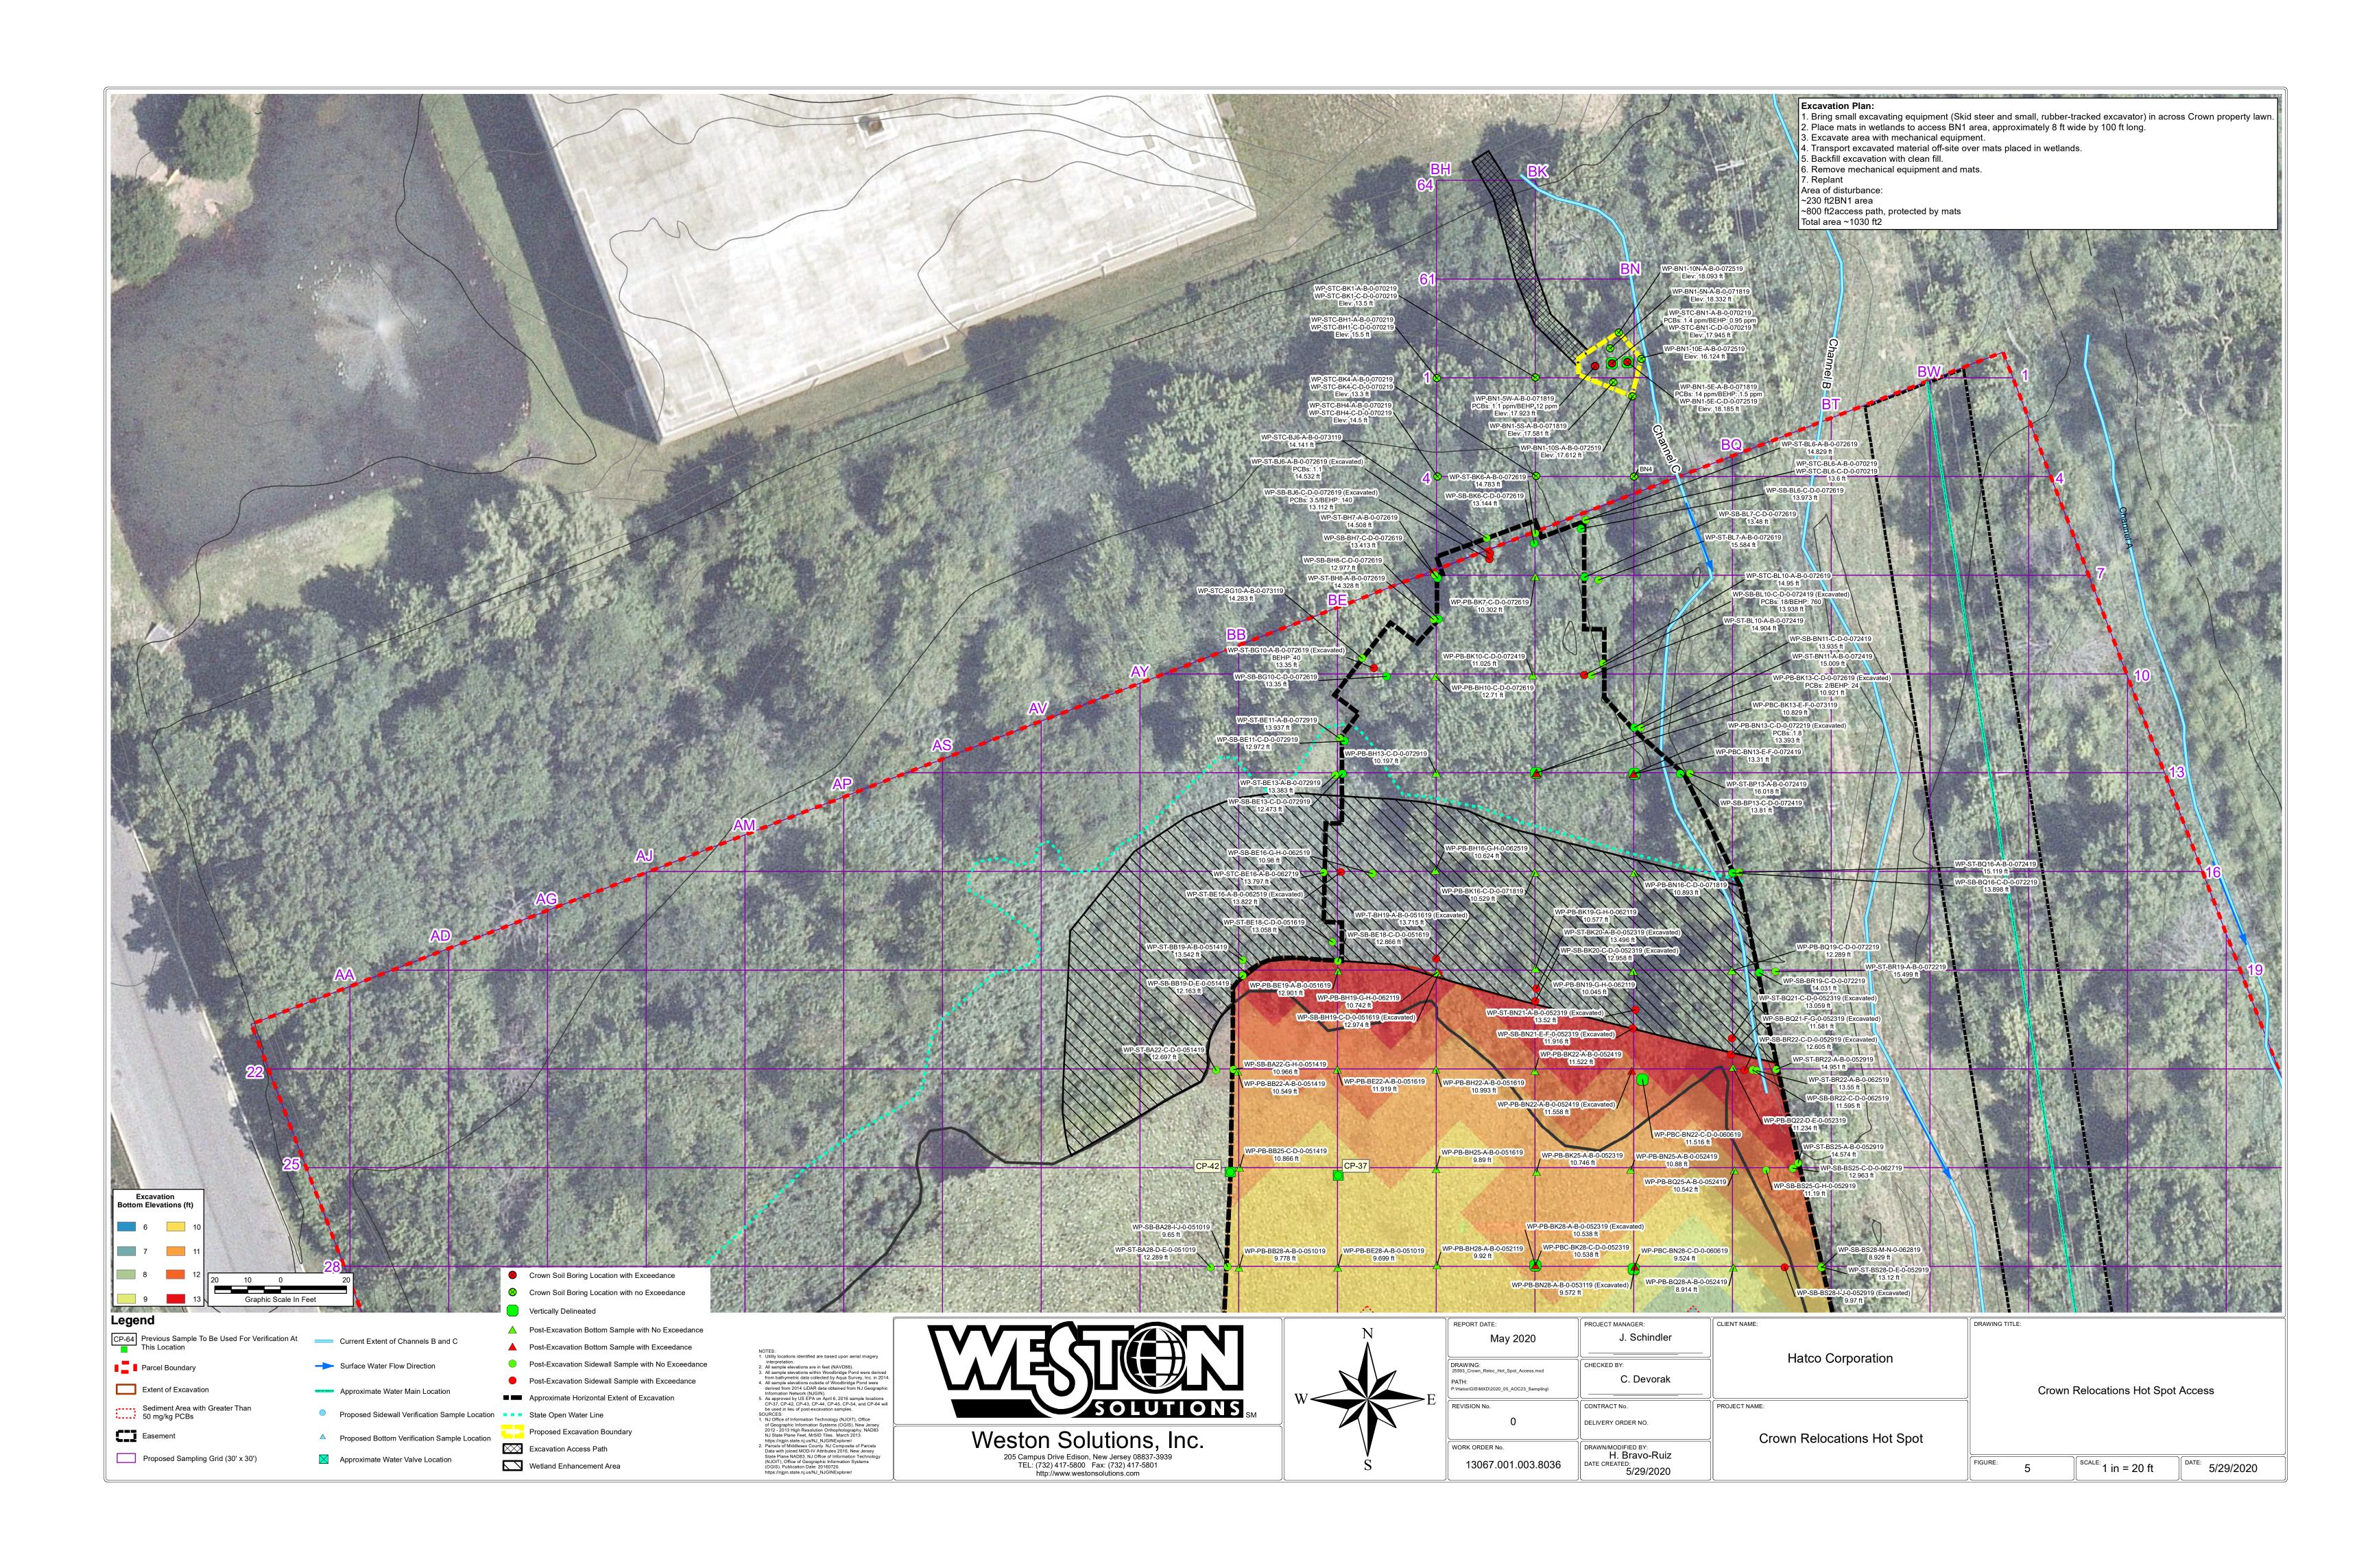
FIGURE 5:

Crown Relocations Hot Spot Access

backfilled with clean fill and seeded using the same materials as approved for the Woodbridge Pond remediation permit. **Figure 5** depicts the access plan.
